# ABANDONED MINE LANDS

# BELT - SAND COULEE, MONTANA

INVESTIGATION OF ACID DRAINAGE FROM ABANDONED COAL MINES AND ASSESSMENT OF POTENTIAL METHODS OF IMPACT ABATEMENT

SAND COULEE AND BELT CREEK CASCADE COUNTY, MONTANA

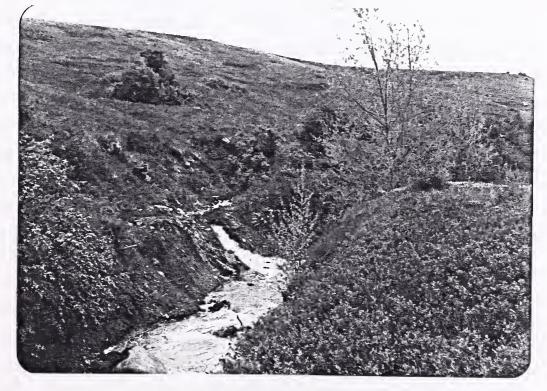
SCM 2 - Mine Discharge Flowing into Sand Coulee May 21, 1981

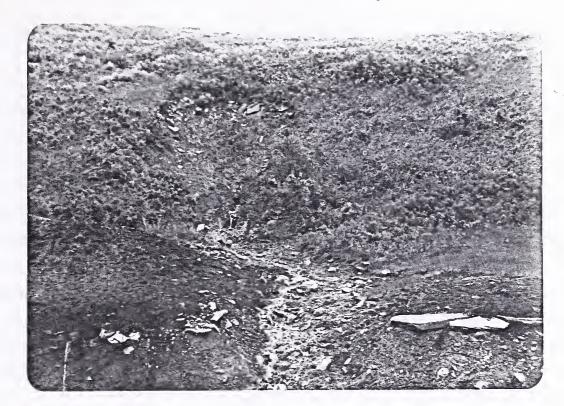
SCM 3 is located along the east side of Sand Coulee about 1200 feet downstream from SCM 2 and less than one mile southeast of the town of Sand Coulee at 19N04E23ADAB. SCM 3 also was part of the Carbon Mine operation. Ernest Chartier is owner of the land. The mine portal has completely collapsed and is filled by rock and soil from the overlying roof materials. The area adjacent to the old mine is covered with a 10 to 15 foot high pile of black colored mine wastes (mostly shale). These wastes extend over an area of about 4000 square feet. A small pond about 8 feet wide by 20 feet long is located about 10 feet from the old mine entrance. The pond is fed by mine discharge which flows from the material filling the portal. Overflow from the pond drains into an iron stained ditch and hence into a wood stave pipe where it drops about 3 feet into Straight Creek.

SCM 3 - Mine Portal and Discharge May 21, 1981

The mine effluent quality of SCM 3 is very poor and is similar to the quality of mine discharge from SCM 2. Table 8 shows the results of analyses of mine water from SCM 3 for several sampling periods starting in 1969 and including recent samples. The mine discharge has a low pH, and very high concentrations of acidity, sulphate, aluminum iron and zinc.

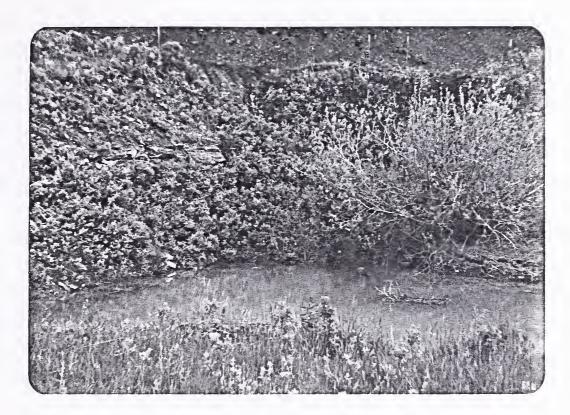
SCM 4 - Mine Portal and Collection Pond

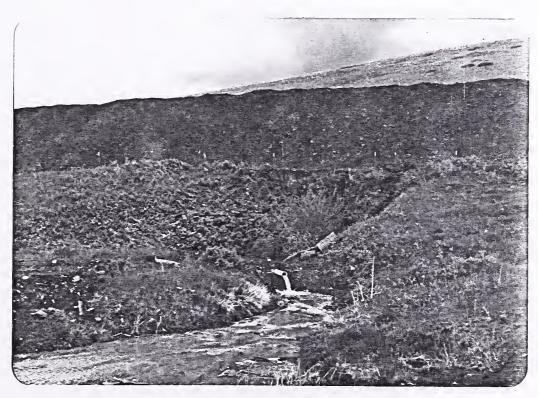
Overflow leaves the pool through an 8-inch diameter plastic pipe and enters a 150 foot long iron stained ditch before it enters Five Mile Creek. Five Mile Creek eventually flows into Cottonwood Creek approximately five miles downstream.

SCM 4 - Pond Overflow and Ditch

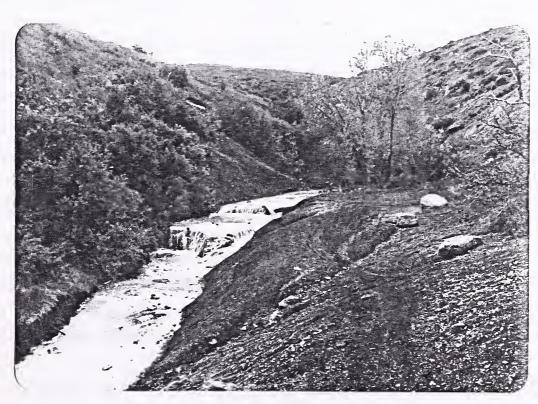
The stream below SCM 5 becomes very turbid and milky colored from the contribution of mine discharge. The stream channel below the water level is covered with a white slimy precipitate (probably aluminum hydroxide). Parts of the stream channel above the water level are reddish orange colored from the iron hydroxide precipitate. The entire stream channel from the mine discharge location to its confluence with Sand Coulee approximately 200 yards downstream exhibits a white chalky color.

Unnamed Stream Downstream From SCM 5 Discharge

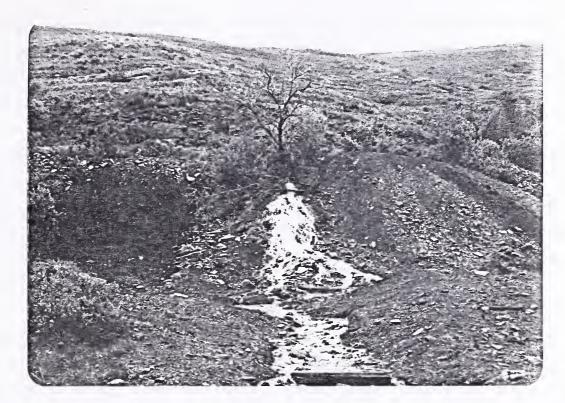
The mine discharge emerges from the mine wastes about 50 feet from the portal where it flows through a 6 inch high by 10 inch wide wooden trough. Discharge from the trough flows down the waste pile into a ditch and eventually enters a stream in the coulee. This stream is partially fed from springs located at the upper end of the coulee but streamflow contains a significant quantity of mine discharge. The stream flows northward along the foot of a hill for about 300 yards to a grain field and is dispersed.

SCM 8 - Mine Discharge

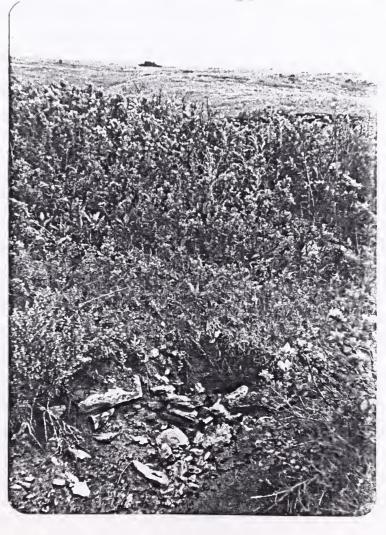
SCM 9 - Mine Discharge

Quality of discharge from SCM 9 is extremely poor (Table 8). The pH of the mine effluent from SCM 9 has ranged from a low of 2.4 to a high of 2.9. Specific conductance has been relatively constant (6170 to 6826  $\mu$ mhos/cm). The effluent contains very high concentrations of sulfate, acidity, iron, aluminum and zinc.

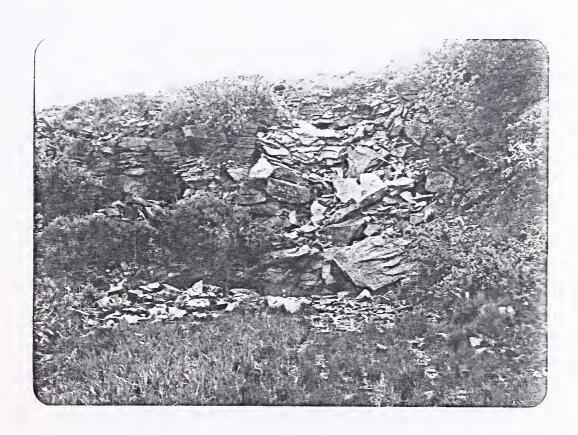
SCM 15 - Mine Portal With Small Iron Stain at Pool at Base of Rock Fill

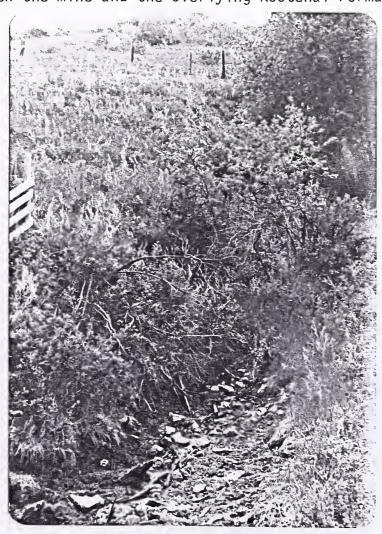
BM 2 - Mine Portal

This abandoned mine is located about one mile south of Belt and is on a steep sidehill on the west side of Belt Creek. The BM 2 adit is completely caved and water exits through a small pipe and runs down a small ditch about 50 feet below a road. The water continues down the hillside to join Belt Creek.

Flow from BM 2 has varied widely (5 to 71 gpm, Table 16) reflecting the influence of precipitation in May and June 1981. Flows rapidly increased, peaked, then rapidly declined showing the good hydraulic contact between the mine and the overlying Kootenai Formation.

Quality of effluent from BM 2 (Table 17) is very poor. Very low pH, high concentrations of acidity, sulfate and dissolved solids and metals make this water much poorer in quality than BM 1.

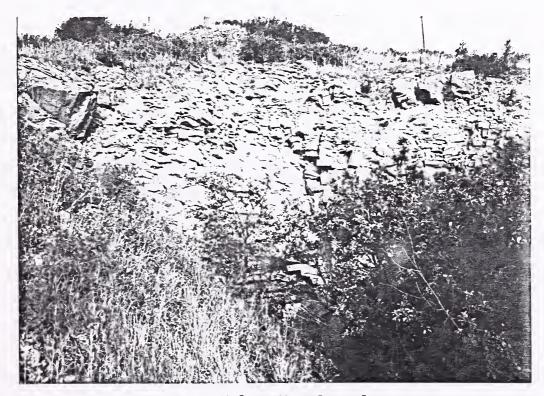
BM 1 - Mine Portal

Mine BM 1 is located just southeast of the community of Belt on a steep sidehill near the community water storage tank (Figure 7). The mine portal has collapsed and water drains into a pipeline and surfaces some distance downhill from the adit. Water from the adit cascades over waste piles down a steep slope and enters a small stream that eventually flows to Belt Creek. The stream channel is heavily encrusted with iron precipitate.

Flow from BM 1 has ranged from 80 to 166 gpm (Table 16) and the effects of heavy precipitation in May 1981 had little affect on the mine discharge.
